# EVENT AUDIT

Greater Mt Maunganui and Greater Tauranga

21 March 2016

Under the Gas (Downstream Reconciliation) Rules 2008 the Gas Industry Company has commissioned Langford Consulting to perform an event audit in respect of GMM08001 Greater Mt Maunganui due to unusually large amounts of positive UFG and GTT 07701 Greater Tauranga due to increasing negative UFG. The purpose of the audit is to ascertain the cause or causes of the UFG.

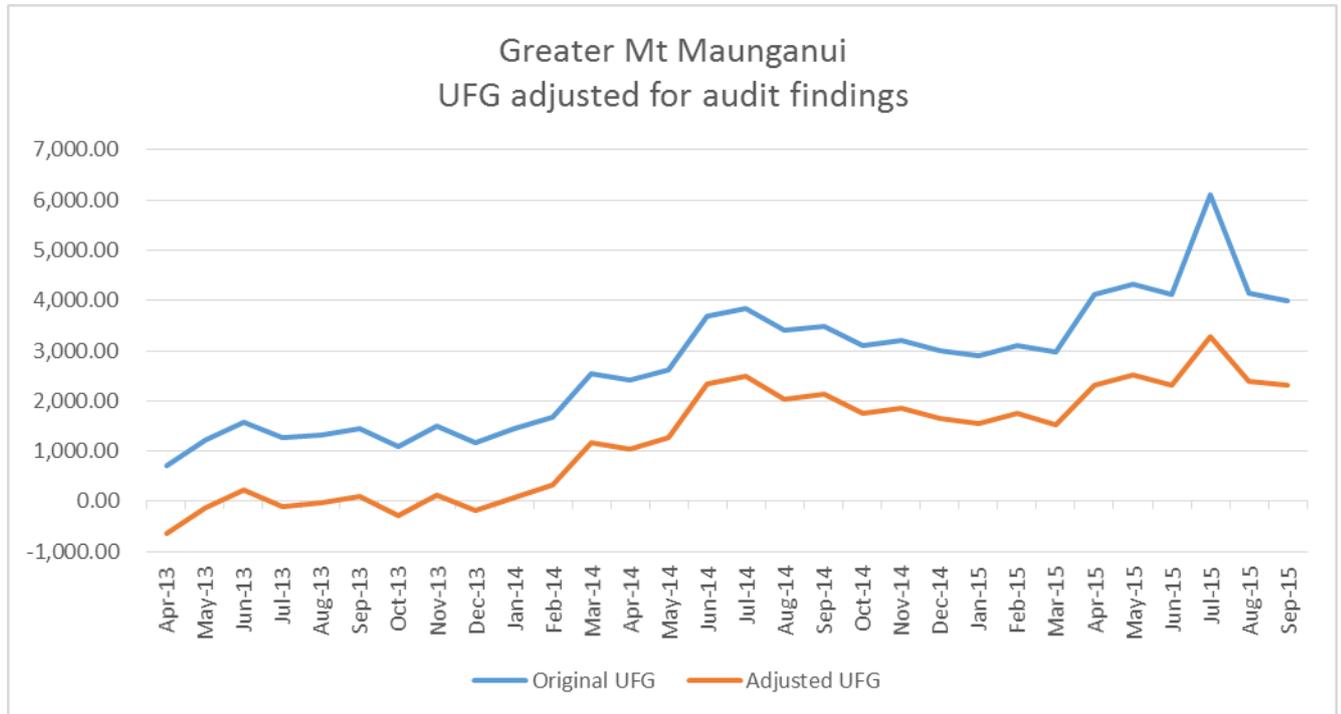
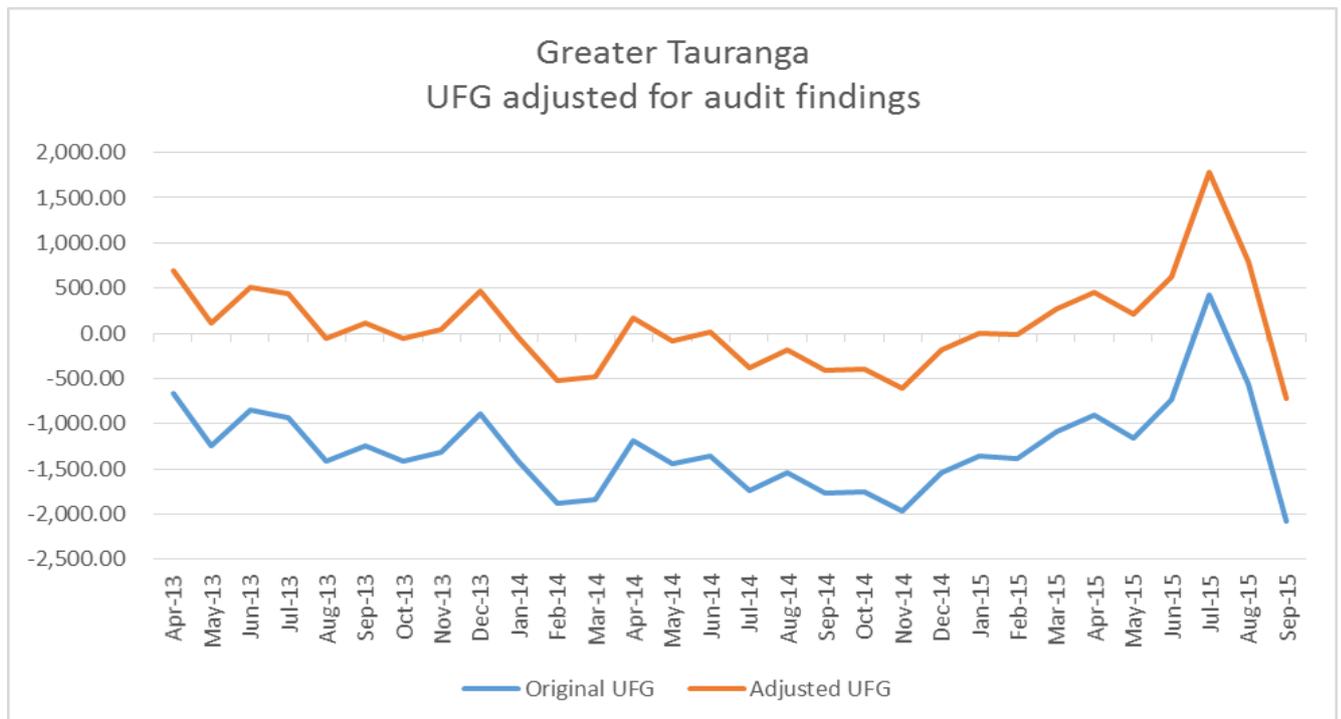
The graphs above show the effect of the audit findings, with UFG being moved substantively towards zero for both gates.

Please note that the original UFG is the UFG prior to the commencement of the audit, as available in October 2015. This means that only the months up to and including August 2014 were final; the months September 2014 to June 2015 were interim and July to September 2015 were initial. The adjusted UFG is adjusted for specific audit findings only, other changes will also arise as a result of the normal movement between allocations. Some of the adjustments involve estimation.

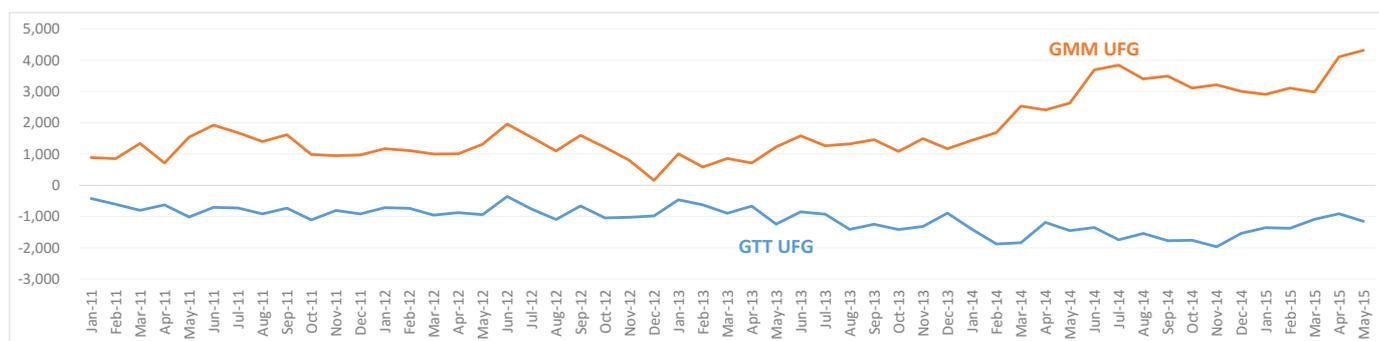
At Greater Mt Maunganui, UFG historically averaged about 1,100 GJ and peaked in the winter at about 2,000 GJs. This pattern appears to have changed from about January 2014. Since that date, UFG has averaged about 3,000 GJs and experienced a peak of 4,300 GJs.

There also appears to be an increase in negative UFG at Greater Tauranga from about this time. At that gas gate, UFG historically averaged about -900 GJ. Since January 2014, negative UFG has increased to about -1,500 GJ per month.

All these factors are sufficient themselves to warrant a gas gate audit. Additionally, the fact that there is significant negative UFG at Greater Tauranga and significant positive UFG at Mt Maunganui, a neighbouring gas gate, as well as the step change in UFG experienced at both gates from about January 2014, suggests the possibility that some ICPs have been mapped against the incorrect gas gate.
