Gas Downstream Reconciliation and Switching Arrangements Performance Audit Final Report

**Powerco Limited as
distributor and meter owner**

Date of Audit: 23-24 October 2024

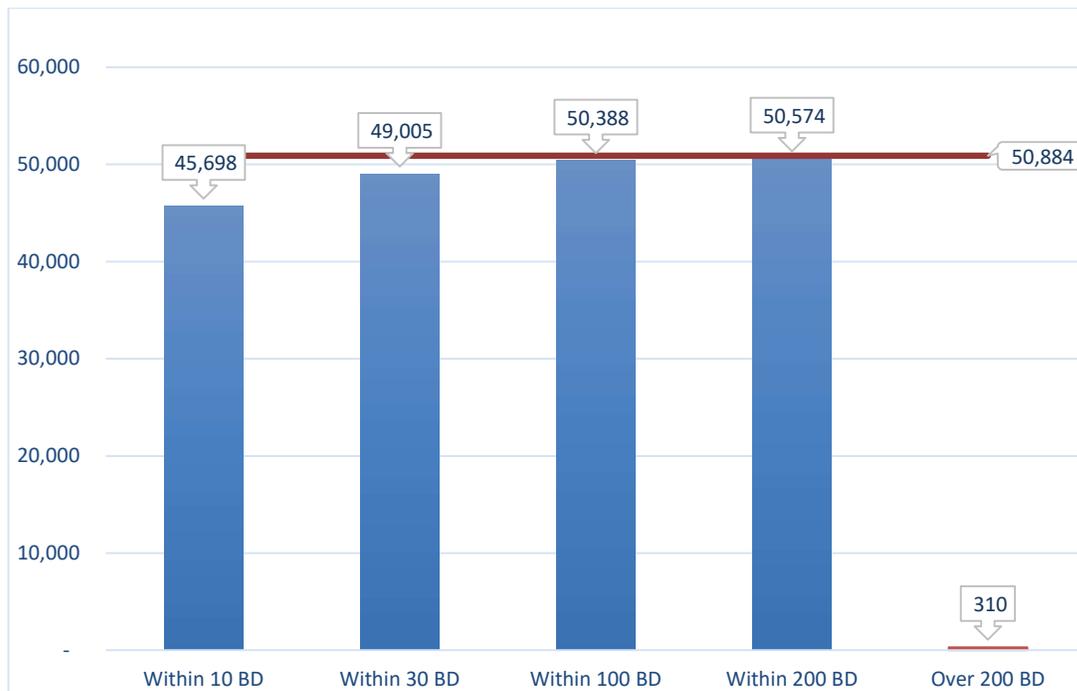
Timeliness of registry metering updates during the audit period

I checked the timeliness of the 50,884 registry updates during the audit period by comparing the event date to the update date. The results are shown on the chart below.

I checked the 30 latest updates which did not relate to new connections and found they were caused by:

- late works completion notices,
- incorrect or incomplete works completion notices which required investigation to confirm the correct details before the registry could be updated,
- backdated corrections to meter serial numbers where the meter serial number effective from the meter’s installation date, and
- changes where a meter pricing end date was updated in CWMS, which reversed the previous meter event and immediately replaced it with a record with the same attributes.
