# **Gas Registry and Switching Performance Audit Final Report**

## **Contact Energy Limited**

Date of Audit: May to July 2026

Date Audit Report Complete: 12 August 2026

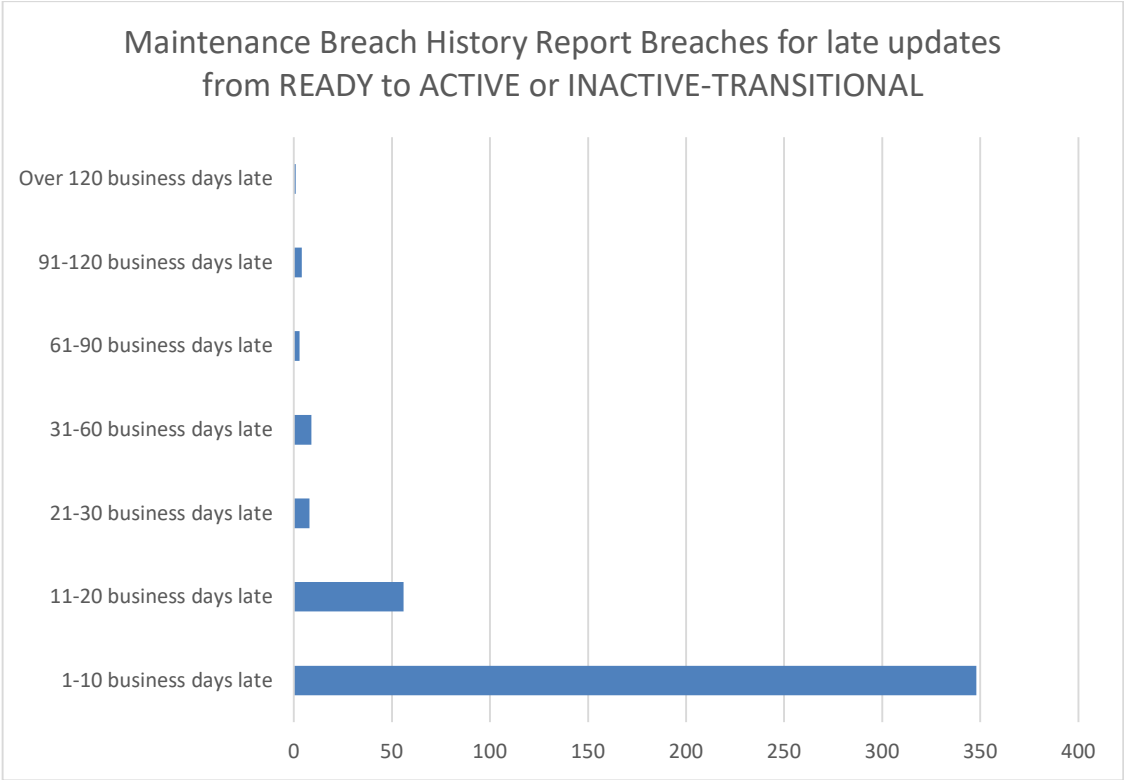
The “Maintenance Breach History Report (RET breaches)” report was examined for the period from 1 March 2024 to 10 May 2026. The report contained 429 ICPs where an update from READY status to ACTIVE-CONTRACTED, ACTIVE-VACANT or INACTIVE-TRANSITIONAL status was made more than two business days after the event date, an improvement from 3,089 for the period from July 2020 to September 2023. The median late update was made five business days after the effective date, the average late update was 9.8 business days after the effective date, and all updates were made within 120 business days of the effective date apart from the latest, which was 498 business days after the event date.

I checked the records for all 25 updates made more than 20 business days after the effective date. None of the 25 updates were claimed within two business days of entering into a contract to supply gas to the consumer. The table below shows the ICPs and the reason for the late updates.

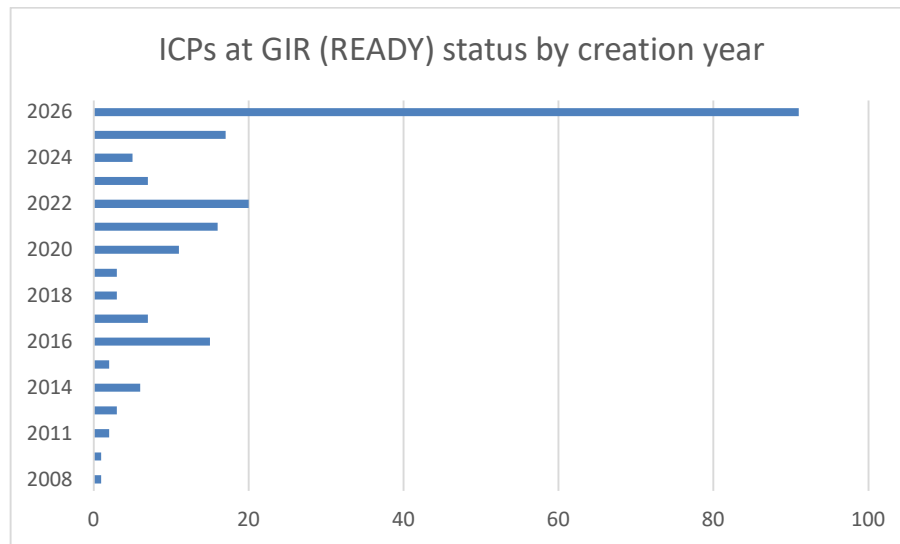
The “RSREADY” report for 11 May 2026 contained 210 ICPs at GIR (READY) status, where Contact was the proposed retailer. 43.3% of the ICPs were created in 2026, and 51.4% were created in 2025 to 2026.

I checked the five ICPs which had a metering event and original commissioning event date. Two were timing differences which were updated to ACTC-GAS once connection paperwork was received in May 2026. For the other three ICPs, Contact has no record of a customer application or accepting the new connection and has not received any connection paperwork.
